# The Khedivial Cairo Revitalization Project

## A case study from Kaser El-Nail Street

This paper will present overview of the revitalization of Khedivial Cairo project, in addition to discuss a case study of the restoration of a building in Kasr Elnil street and the work difficulties, attempts to find solutions and development of responses to these difficulties, these solutions should preserve the identity of the heritage building.

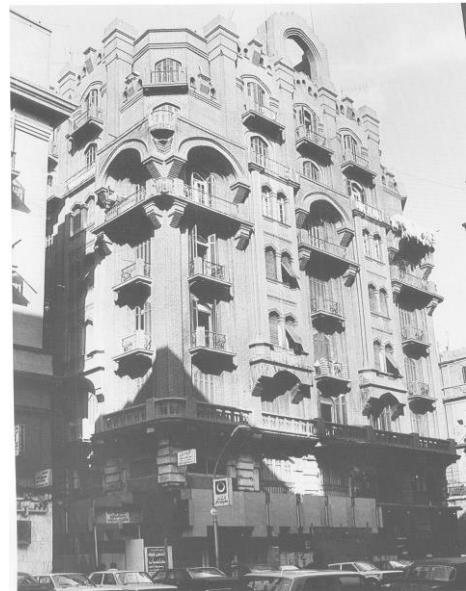
**Fig 3: The main façade of the building from Kasr Elnil Street**

The (Fig 3) [10] shows the main façade on Kaser El-nile street.

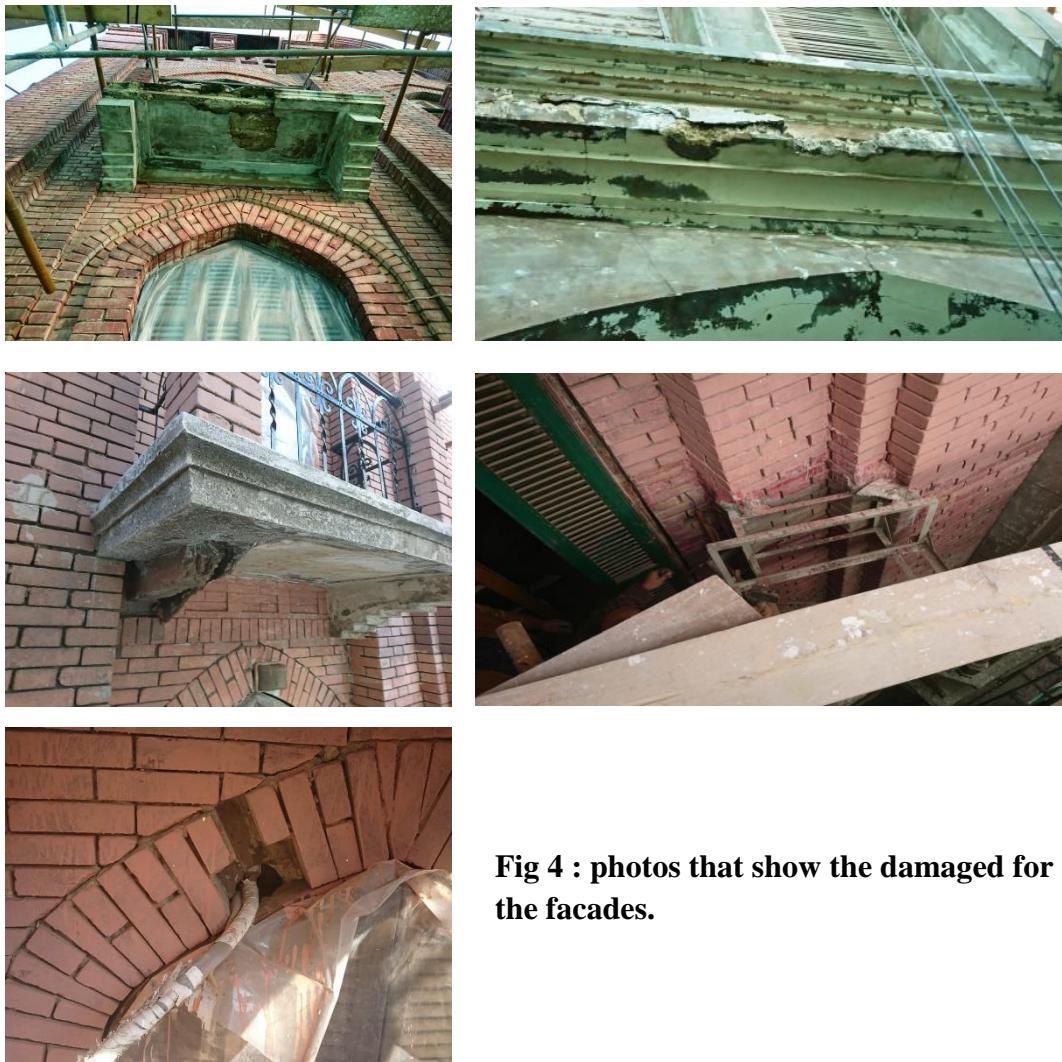
**Fig 4 : photos that show the damaged for the facades.**

**4.1. From the exterior:** Most of the apartments of the building are used as clothing stores or as a warehouse for these stores, for that the owner of this shops didn't take care of the building as a heritage building, as they put the air conditions, satellite dishes, advertising banners, and wires on the external facades, also many layers of different types of painting were found, as a result, the exterior façades were distorted and lost their heritage architectural value, The residents of the building also did not care about making gutters to drain rain water and didn't care about Sewer pipes which led to damage to the decorations and plaster cornices, as well as damage to the concrete of the external balconies floors.

Firstly, eliminating all the rickety concrete, then exposing the iron and sanding it, then all the corroded iron poles were replaced with new iron poles have the same diameters, followed by painting the concrete surfaces with (*Sika Ferro Gard 903*) in order to delay corrosion and rust and increase the life span of the concrete.

Then painting the concrete and iron surfaces with (*Sika Top Aromatic 110 Eposem*) for protection against rust and to connect the new concrete with the existing concrete,

Then the rebar was covered with a mixture consisting of 80m<sup>3</sup> fine gravel : 40m<sup>3</sup> sand : 400Kgms cement with the addition of (*Sika Fly-Ash*) in the mixture to improve the final surface and reduce shrinkage, after that putting the final layer of cement plaster with the addition of (*Sika I*) to the cement mortar.

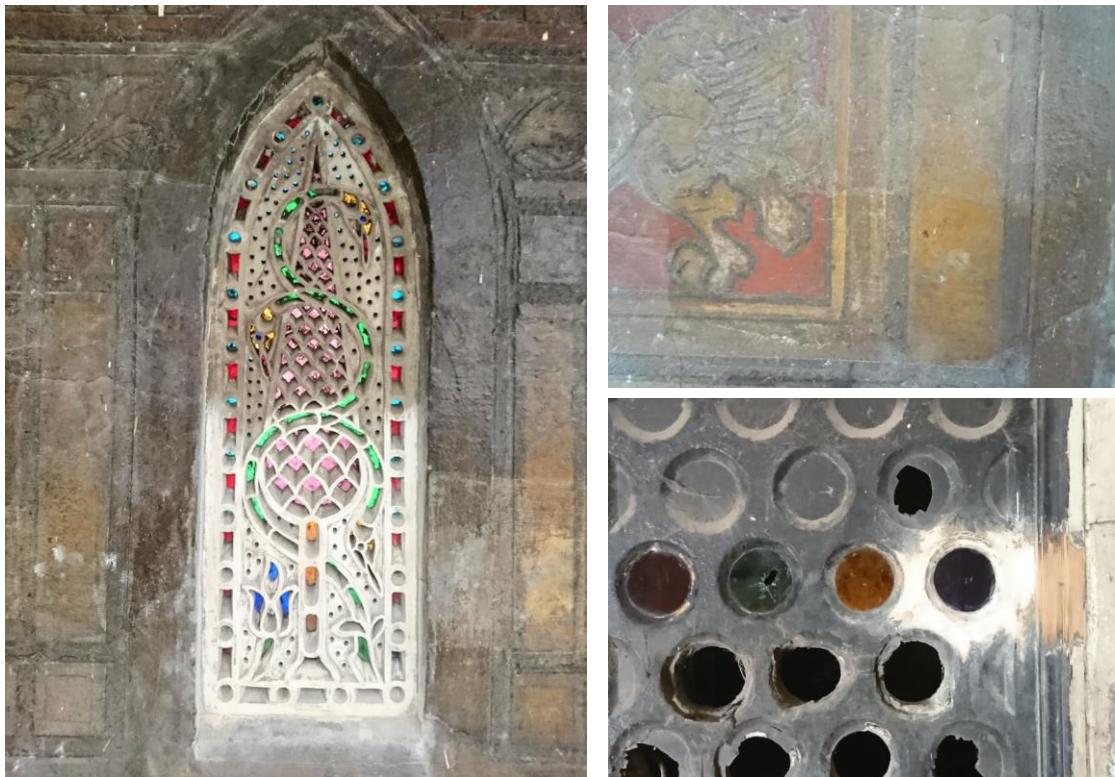
**Fig 5: the lack of maintenance for the main entrance.**

Due to the changing of the use for many units from the residential to clothing stores or as a warehouse, many units had been changed from the original design, like to remove some walls to have a bigger, or to remove the solid walls and to make as a shop window. Also an elevator has been added to the building in the main stairs void. In addition to, the lack of maintenance to the hand paintings, and the Gibson windows that had been done by the traditional ways.

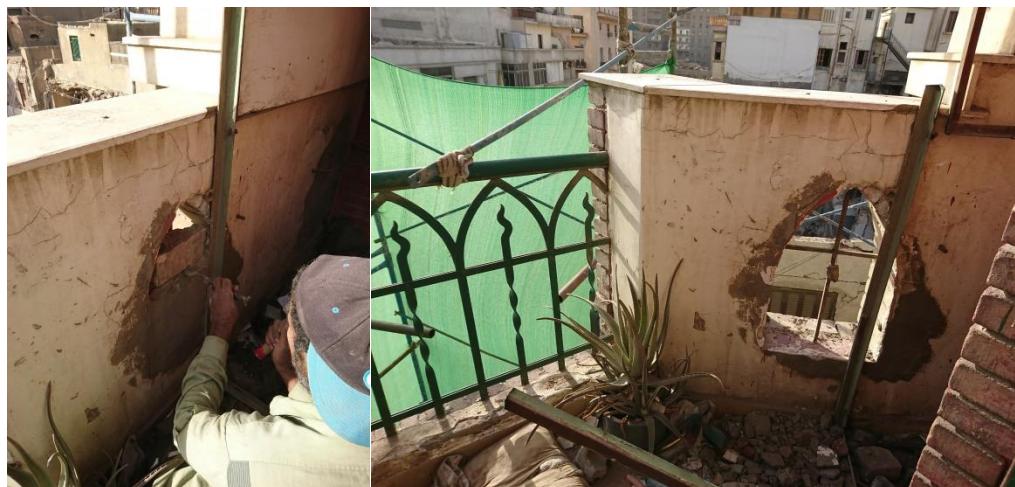
Figures 7: Reopening of the closed old openings

Also the small windows in the balconies which were closed by bricks were open as it was, also elimination the metal and the wooden ceiling which were put on the top of the façade.

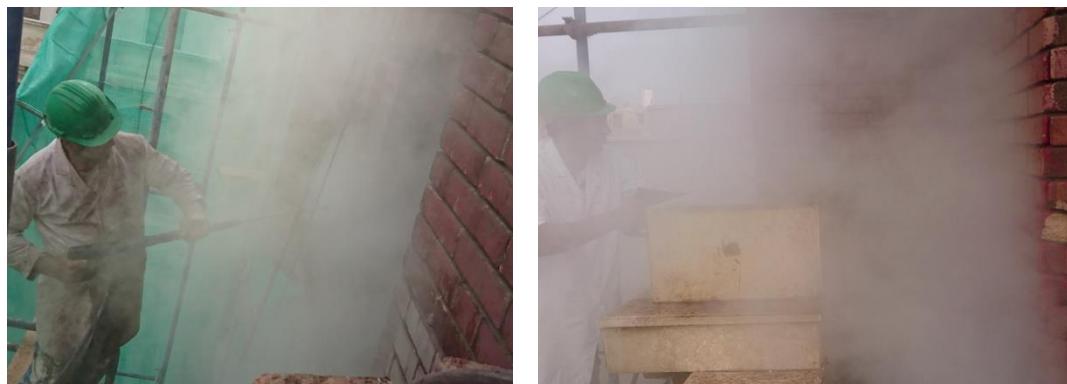
**Figures 8: Cleaning the facades with steam cleaning system**

Steam cleaners can broadly be divided into small industrial/domestic units and the larger machines (such as Doff and ThermaTech) that are commonly encountered in building conservation. Steam cleaning system was used for cleaning the façade, one of the best benefits of steam cleaning is that it eliminates these nasty elements from facades, and when steam penetrates surface pores, it removes dirt, debris, bacteria, and other tiny elements with hot vapor molecules, adding that steam remove the layers of over paintings easily.

The Steam cleaning system is non-obtrusive and non-damaging to surfaces and substrates. It can clean rapidly and leaves the surface looking restored and fresh.

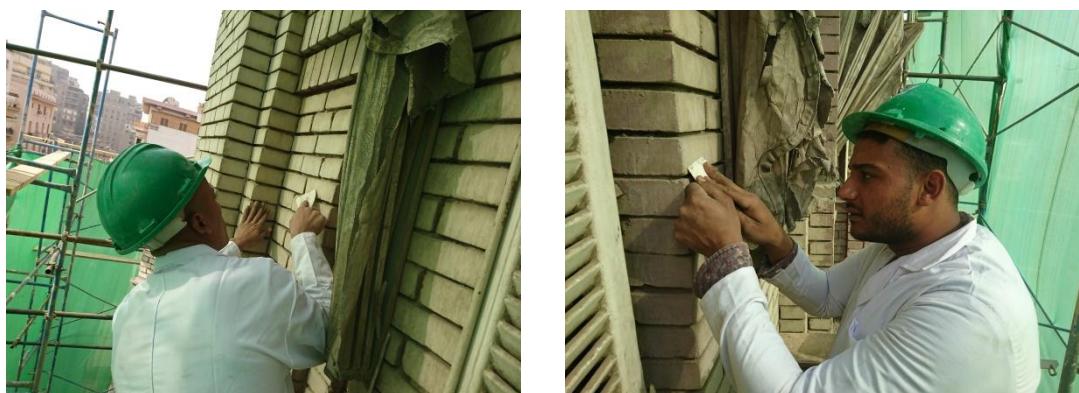
### **Figures 9: Mechanical cleaning to the hard cleaning surfaces**

After steam cleaning, some solid dust and cement calcifications on the surface couldn't be removed by steam, so metal tools were used to remove these calcifications by mechanical cleaning without any liquids.

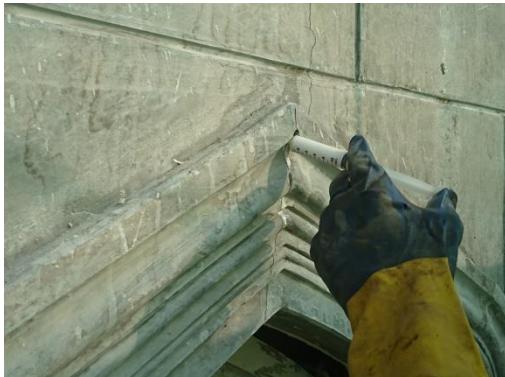
Fig 11: injection by Acril 33 20%

The big cracks in plasters were injected by a mortar consisting of white cement 1 : lime 1: 20% acrylic *Acril 33* for the Italian company CTS, and this was after injection with water and alcohol to clean the dust inside the cracks.

The small cracks were injected by Acril 33 20%.

The cracks were injected by Acril 33 20%.

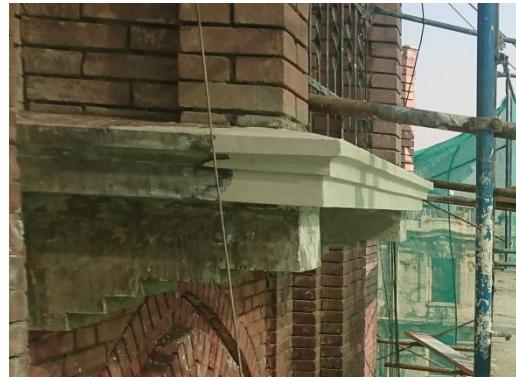
Fig 12: integration of missing parts

The cornices and plasters were highly damaged, and many parts were missed, so the missed parts were integrated by a mortar contains[15]:

1 white cement : 3 gypsum : 10% *Addibond 65* from CMB, and before putting the mortars, the walls were cleaned so well by water to eliminate any dust, after

As for the stucco cornices, they were integrated by a mortar consisting of white cement 1 : gypsum 3 : 20% Addibond 65.

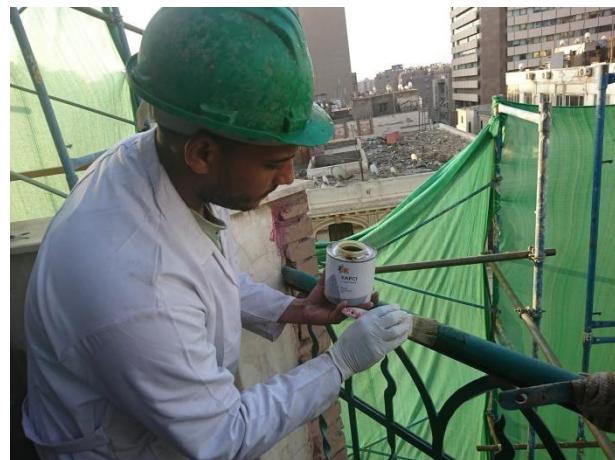
Fig 13: removing over paintings from metal handrail

The handrail had many layers of paintings, so heaters were used to eliminate these layers, after heaters, chemical removers were used to clean the rest of the paintings.

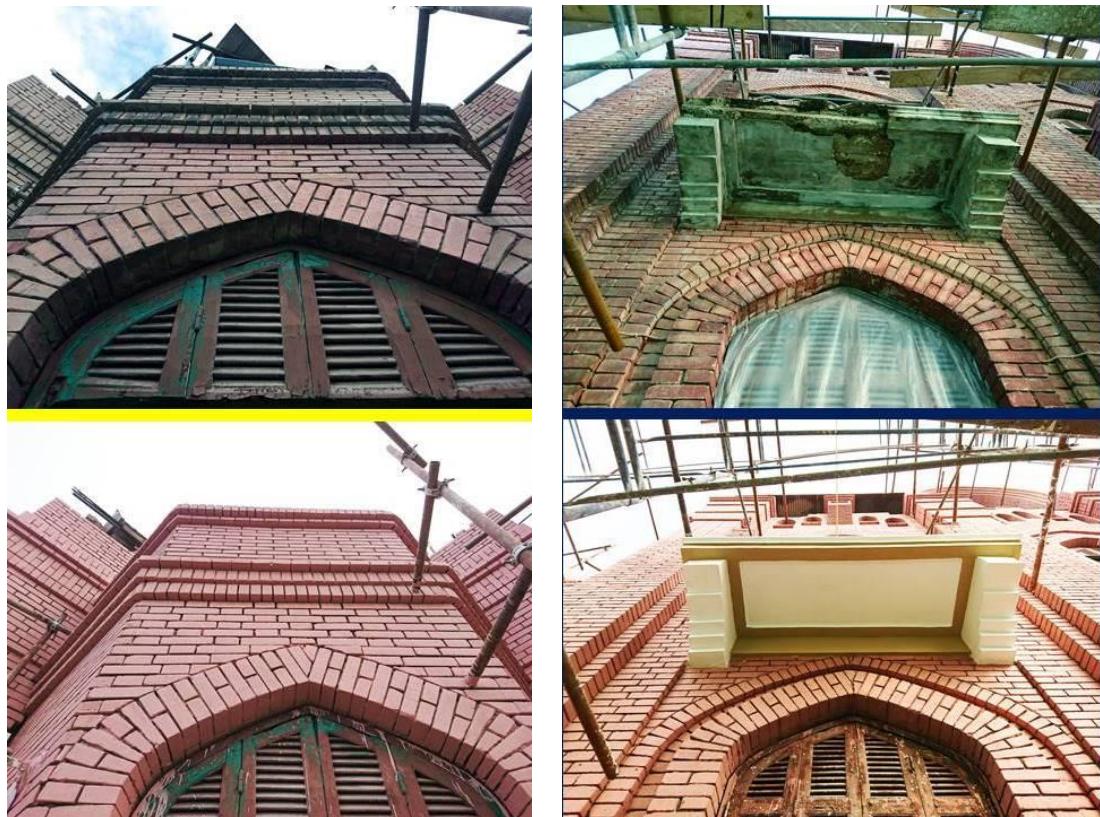
Fig 14: the result of the balconies and arches before and after restoration

After steam cleaning, specially the higher parts where people can not arrive, we could get the original colors of the painting, and after many trials we could arrive to the colors degrees.
