THE FLEXURAL BEHAVIOR OF CORRODED OFFSHORE RC BEAMS REPAIRED BY DIFFERENT TECHNIQUES

ABSTRACT

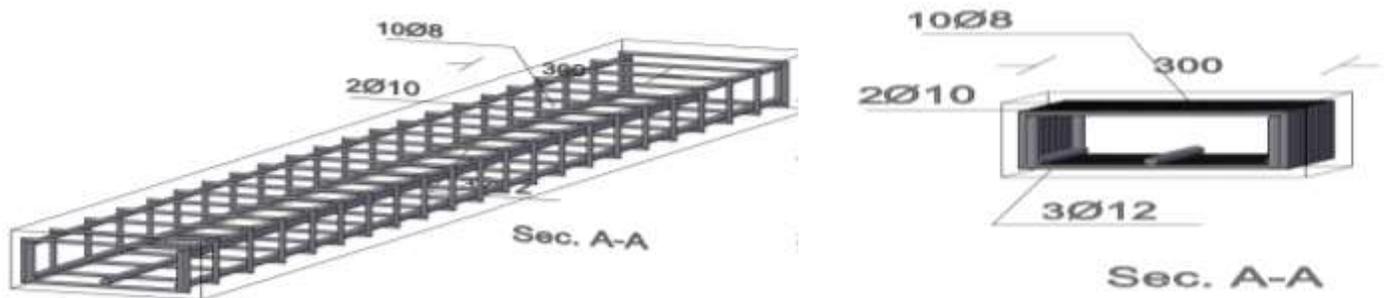
Figure 1. Reinforced detailing of RC beam.

Five RC beams were tested in current study. The tested specimens were 220-cm long RC beams with a 30 x 15 cm cross-section and reinforced detailing as shown in Figure 1. The experimental program consists of one beam as reference and remaining four beams were exposed to offshore climate and three of them were rehabilitated of corrosion with different techniques. The beams are as shown in Table 1.

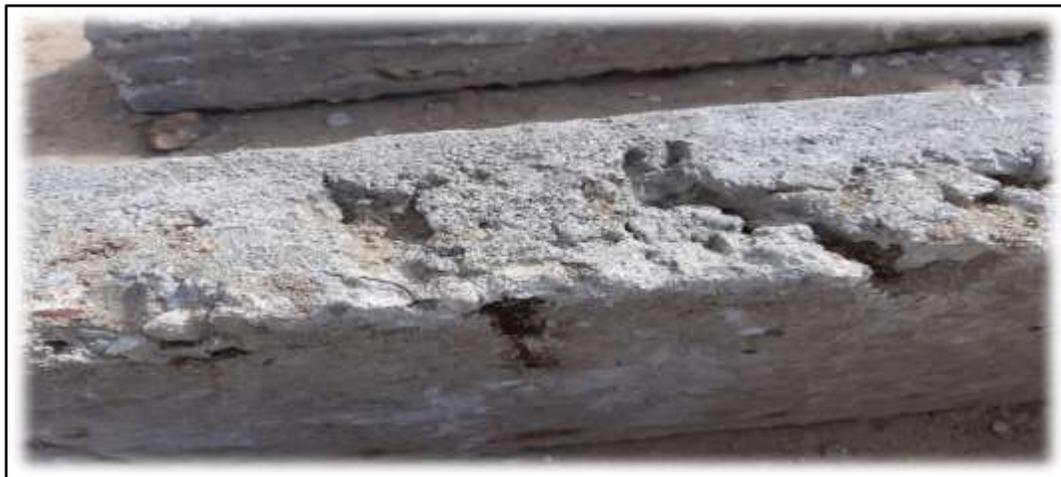
Figure 2. Beam B3 after it was exposed to offshore climate before being repaired.

This technique (B-03) zinc rich epoxy was utilized to repair the corroded steel bars at defected areas as shown in Figures 2, the grout was cast to compensate the old concrete cover.

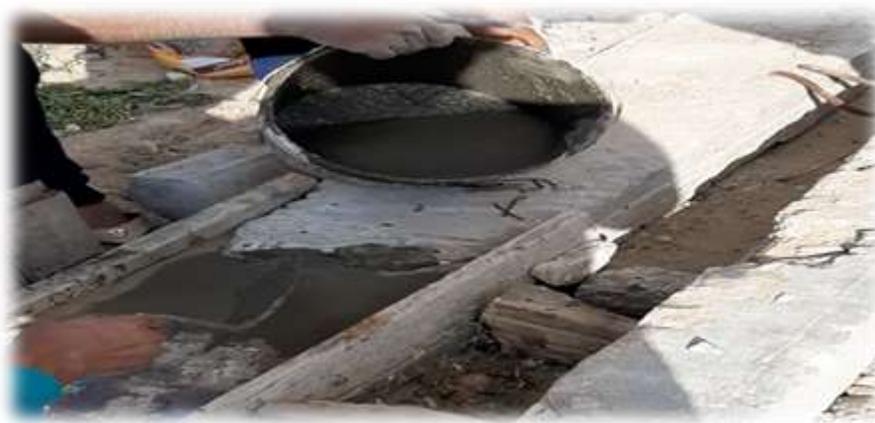
Figure 3. Beam B3 after being repaired with Sika zinc rich epoxy and Grout.

1. Remove of the weak concrete cover at specified locations until reaching the reinforcing steel bars and remove corroded layer of the reinforcing steel bars using hand and power tools.
2. Apply two coats of anti-corrosion painting for the existing treated steel rebar and back of steel bars, Sika Zinc Rich -2 and clean the concrete surface at the treated areas by compressed air and water jet to remove any loose parts.
3. Apply the bonding agent and pouring Sika grout 214 as shown Figure 3 to compensate the concrete cover.

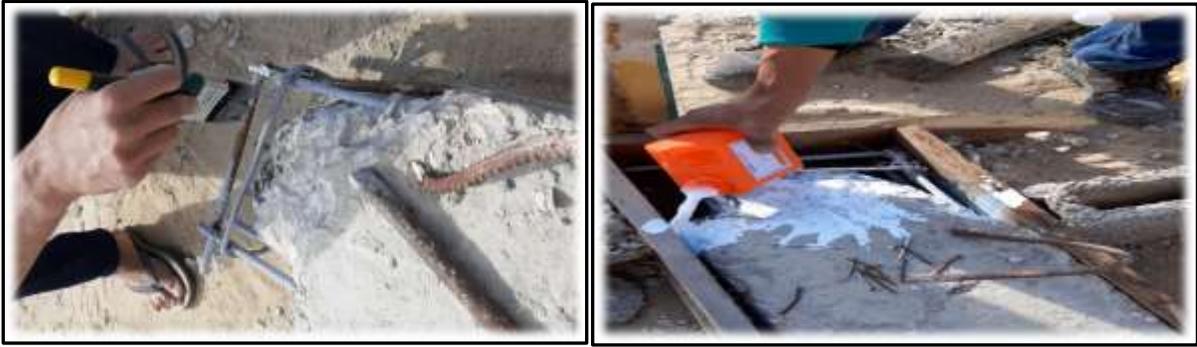
Figure 4. Beam B4 after being repaired with Sika zinc rich epoxy and adebond.

In this technique (B-04) mastic epoxy was utilized to repair corroded steel bars at defected areas and new concrete was cast as shown in Figures 4.

1. Remove of the weak concrete at specified locations until reaching the reinforcing steel bars.
2. Remove corroded layer of reinforcing steel bars using hand and power tools. Then applying two coats of anti-corrosion painting for the existing treated steel rebar, (mastic Epoxy- Jota mastic 87) as shown in Figure 4.
3. Form work using plywood, pouring new concrete.

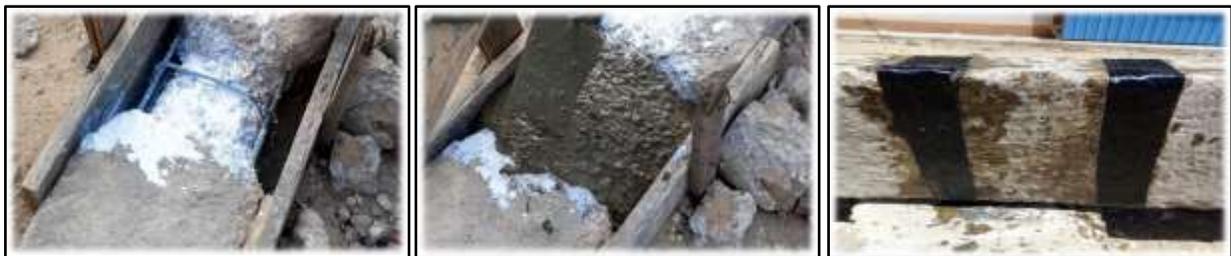
Figure 5. Beam B5 after being repaired with Sika zinc rich epoxy, adebond and CFRP.

1. Remove of the weak concrete at specified locations until reaching the reinforcing steel bars.
2. Remove corroded layer reinforcing steel bars using hand power tools, apply two coats of anti-corrosion painting for the existing treated steel rebar, mastic Epoxy- Jota mastic 87 as shown in Figure 5.
3. Form work using plywood, pouring new concrete.
4. Applying CFRP for strengthening the beams.

The RC beams had corrosion along the whole length of the specimen. The flexural performance, with the exception of ductility, of the strengthened and corroded beams was improved. The behavior of specimens strengthened with transverse CFRP wrapping only as shows in Figure 5 . The continuous transverse laminate provided a small increase in the yield and ultimate strength as a result of the transverse strength of the laminate. The difference in yield and ultimate load between B1 and B5 is small. Thus, the continuous transverse sheet was successful at maintaining the majority of the yield and ultimate strength of beam B5. The yield and ultimate strengths of beam B5 was 9% less, respectively, than the corresponding values for beam B1.

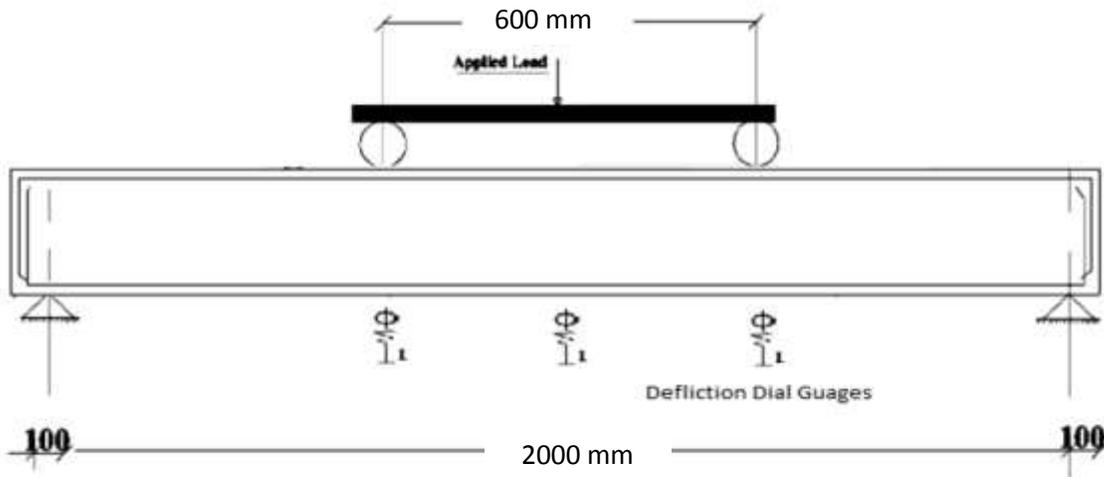
Figure 6. Test Set-up.

The non-repaired RC beam (B1) was loaded at age of 28 days. The corroded RC beam (B2) was loaded at 600 days after corrosion was completed. And, the repaired RC beams (B3, B4, and B5) were loaded at 600 days after being repaired. All specimens were loaded under 4-points loading with a total clear span of 2000 mm. The distance between loading points and shear span were 600 mm. Displacement dial gauges were installed at the middle of the specimens and at the location of loading points. Monotonic loading was slowly applied to specimen. The load cell was installed in order to measure the exact load applied on the specimen and cracking observations were performed every 10 KN of load. The loading continued until the specimens failed. The overall view of the flexural test setup is shown in Figure 6.

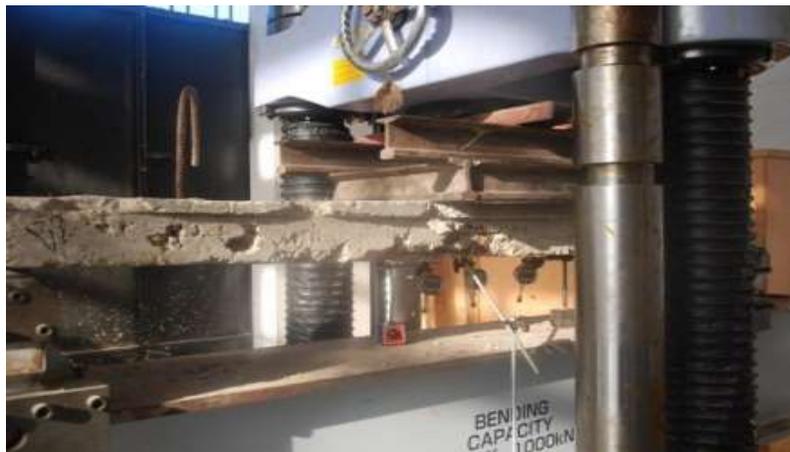
Figure 7. Corrosion pattern in RC beam B2.

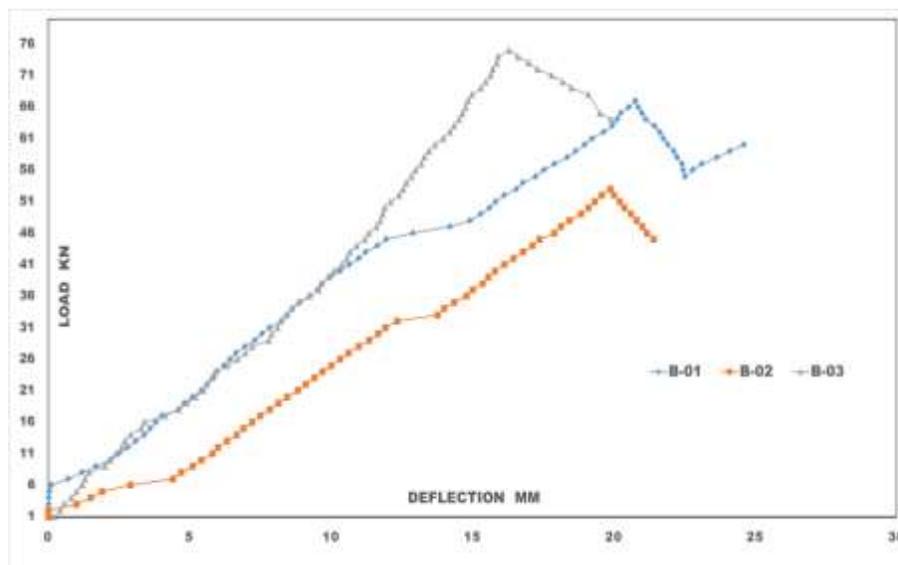
Figure 8. Load-Deflection relation for B1, B2 and B3.

The load deflection relations for the beams are shown in the following Figures. Figure 8, shows compare the load deflection diagrams of control beams B1, B2 and beam B3 repaired with Epoxy and Grout technique. The beams behaved linearly until cracking load and the deflections were almost the same until the start of yielding of the tension reinforcement. In this post-yield phase, the greater the percentage of reinforcement corrosion B2, the greater was the deflection for a given load. Deflection values were less for repaired beam than for the beams without repaired at the same load.

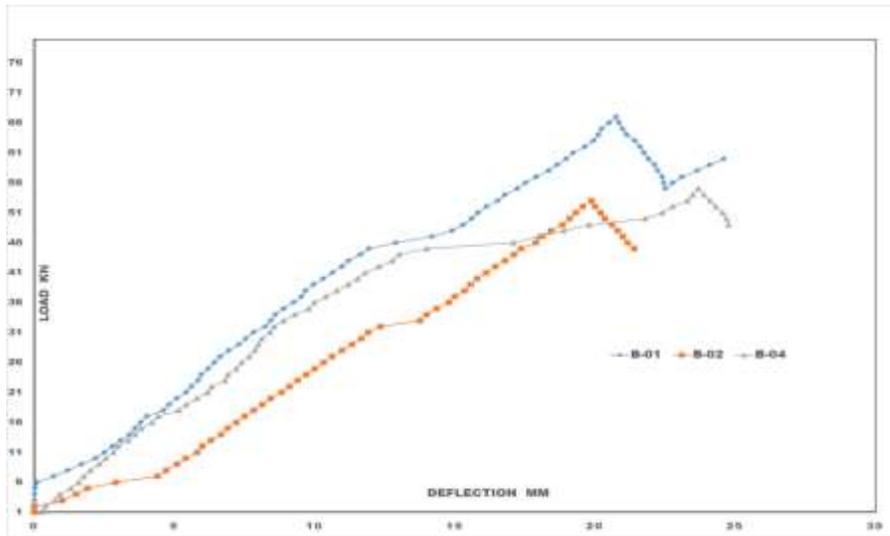
Figure 9. Load-Deflection relation for B1, B2 and B4.

Figure 9b shows the behavior of repair beam B3 with Grout. The tensile steel reinforcement of the strengthened specimens was corroded. The load-deflection response of the control beam B1 and the strengthened beam corroded B3 are shown for comparison. The strengthened beam exhibited increased stiffness over the strengthened beam, and marked increases in the yield and ultimate strength. However, the ductility was reduced in comparison to strengthened beam B3. The increase in yield and ultimate strength of the strengthened beam were on average 8% and 12%, respectively. The ultimate strengths of beams B2 and B4 were almost identical. The ultimate strength of beam B4 was only 4% greater than the ultimate strength of beam B2. Thus, the adding new concrete did not have any significant effect on the ultimate strength of the beam B4. Beam B4 exhibited ultimate strength, which were 18%, less than the ultimate strength of control beam B1.

From the Figure 9, it seems that adding the Epoxy and Concrete has had very little effect on the member stiffness. Also, the B4 showed similar behavior, the beam behaved linearly up to the cracking load, and later the yielding point was clearly detected.

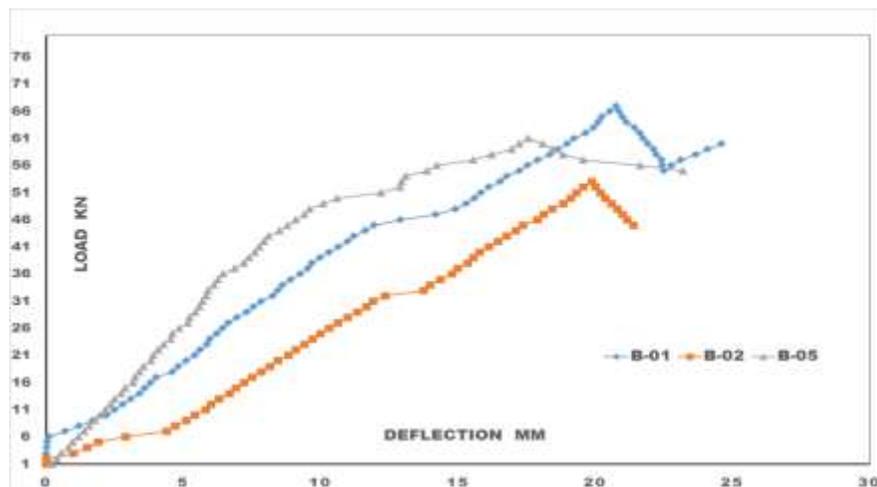
Figure 10. Load-Deflection relation for B1, B2 and B5.

The effect of bonding a CFRP to the beam is introduced in Figure 10. The beam was strengthened with CFRP, exhibited almost linear behavior. Deflection values were less for all beams than for the beams without strengthening at the same load. It may be concluded that composite action between the CFRP and the beam was achieved. This resulted in higher stiffness for the strengthened beam than the reference beam leading to an approximately elastic behavior of the strengthened beam up to failure.

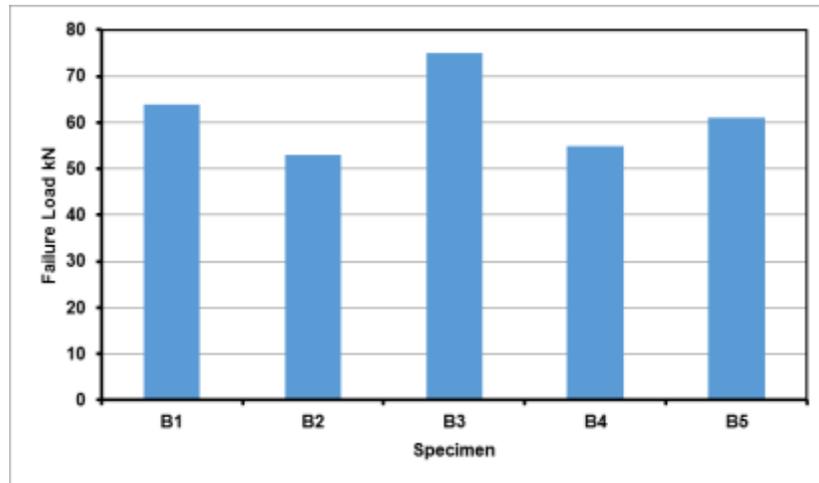
Figure 11. Effect of Different Techniques on Failure Loads.

Since one of the objectives of this research was to find the corrosion level affected the failure load and identifies the effect of strengthening the beams using different techniques on the failure loads. Figure 11 shows the comparing the failure load. It is seen that strengthening beams exhibited higher value of failure load than the unstrengthen beams at corrosion level.

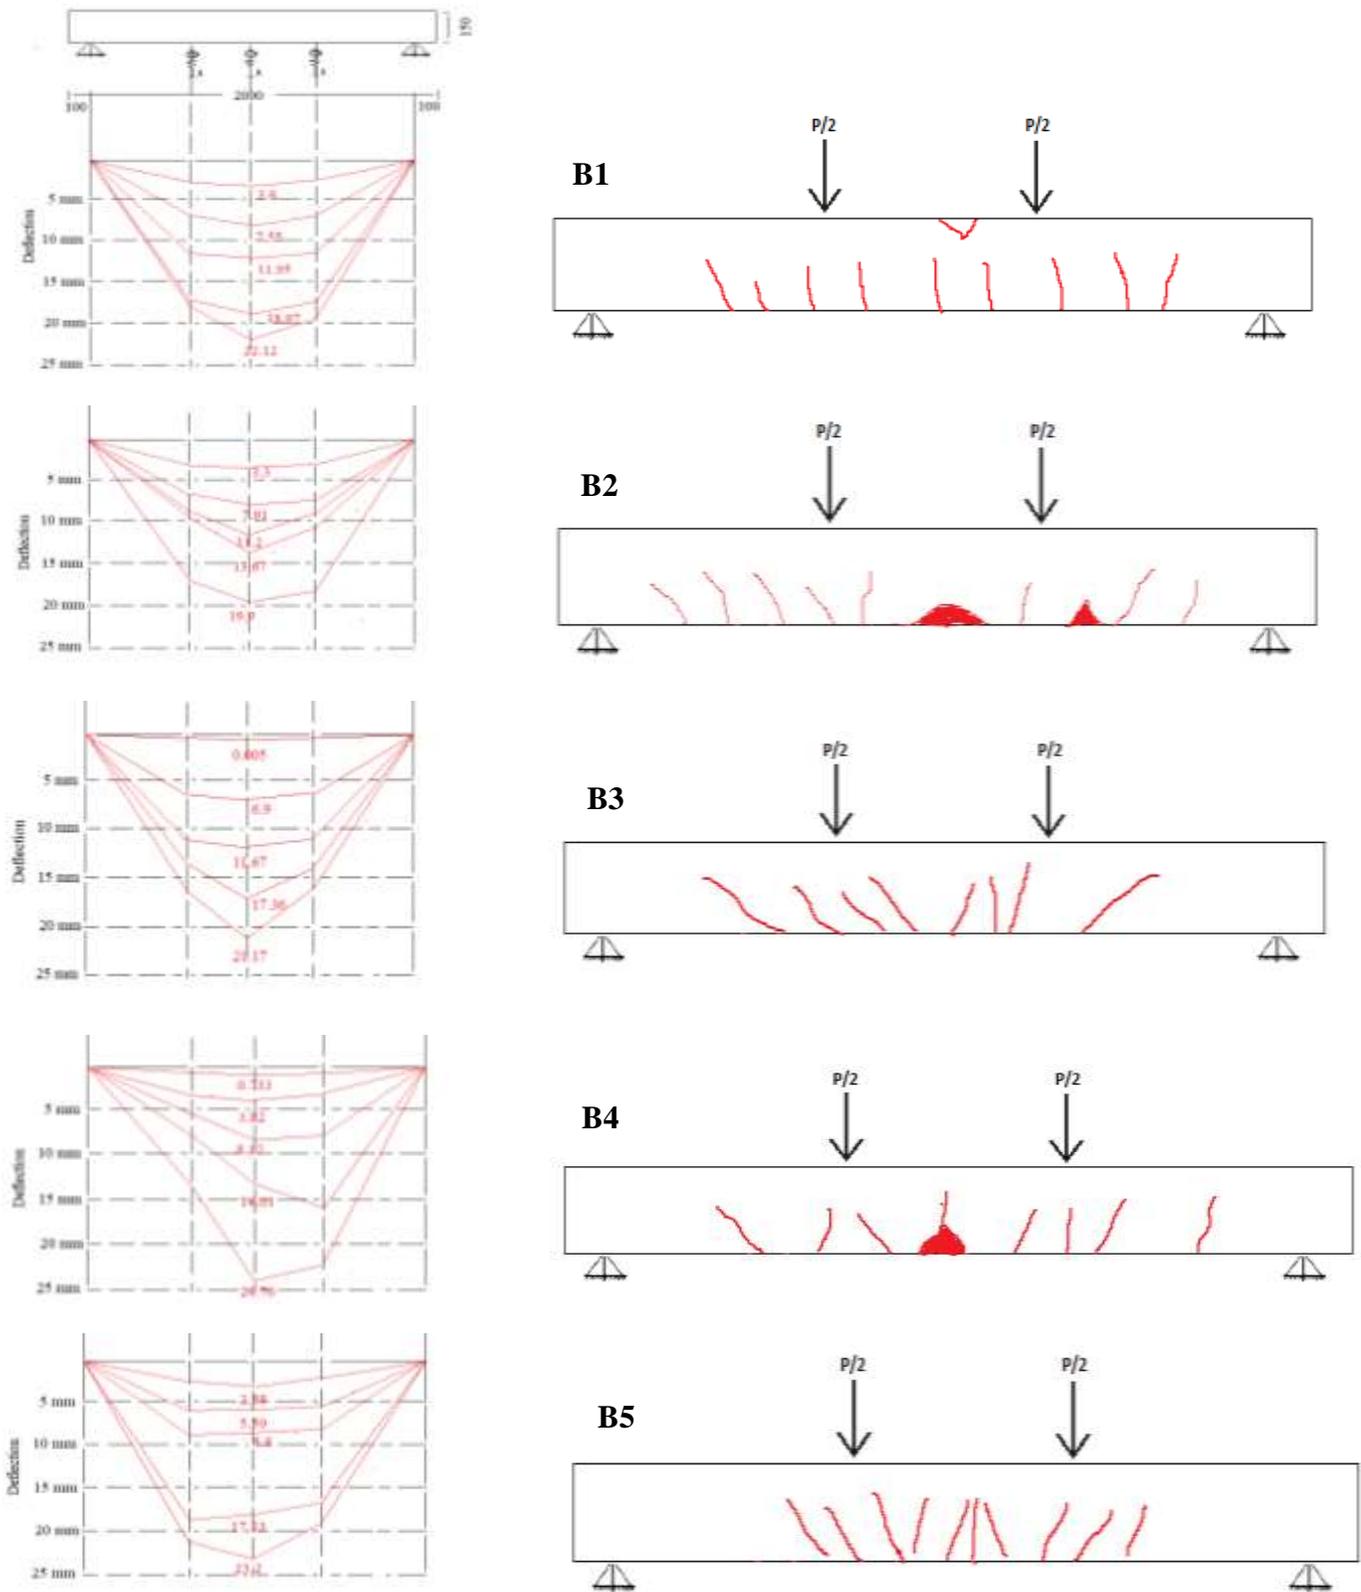
Figure 12. Load-Deflection Curves and Cracking Pattern.

This beam showed different results compare to B1, as that beam was exposed to offshore climate conditions for about 600 days without any method of repair. Therefore, deflection showed since the beginning of loading at 1.0 *kN*, as a result of being severely affected by the environment in which they were present and erosion of the reinforcing beam, and this became clearer with the appearance of the first crack at about 35 *kN*, a difference of 10 *kN* from the control beam, then cracks quickly followed, with the appearance of fractures in the concrete cover and the appearance of cracks in the shear area with the increased loading other than the first beam. This shows the great impact of the attack of chlorides on it, it began to collapse the beam is at 53 *kN*, which means that the bearing force is about 20% less than the control beam. The bending appeared convergent under the two loads and increased in the middle by about 5.0 mm, but the bending did not go beyond the control beam, which explains why the steel bars greatly preserves its tensile strength properties despite It goes through environmental conditions that expose it to rust. In the following chart in figure 12 shows the crack pattern.

repaired by zinc rich, due to the advantages of characterized by the grout, as it is highly strengthening , and then cracks follow, including areas of shear. However, there was no break in the concrete cover as in B2, and there were no cracks in the area between the old concrete and the grout, which shows the efficiency of the bonding material. The beam endured up to 75 *kN*, increased on the control beam, at 11%. In the following figure 12 shows the crack pattern.

In this beam, the bending behavior is similar to the behavior of the control beam, greatly in the way of bending and the appearance of cracks, but with the difference in the load of the crack and collapse, the load increased even with an increase in the deviation until the appearance of the first crack At 45 *kN* in the middle of the beam, cracks continued under the two loads in the middle and a link to the shear area until the collapse load was at 55 *kN*, approximately 18% less than the control beam, which means that the beam is greatly affected by exposure to coastal conditions despite the use of a maintenance method that includes Epoxy for steel exposed to rust in addition to concrete that did not reach the same efficiency as the control beam, and it proves that this method is less effective than its predecessor in B-03 with regard to the bearing strength of the beam and its resistance to collapse. In the following figure 12 shows the cracks pattern.

This beam showed good performance when loading, as it showed different performance of cracks in terms of where they appeared, where the first crack appeared in the middle of the beam at about 50 *kN*, which means its preference over the control beam, in which the first crack appeared about 45 *kN*, by 10%, and then the cracks followed. It was concentrated in the middle of the beam and under the loads without any cracks appearing in the Shear area due to its reinforcement using CFRP which showed good and expected performance in the bearing strength of the beam and its resistance to cracks in the shear area. The beam began to failure at about 60 *kN*, which is not significantly less than the control beam despite the conditions experienced by the beam before the repair process with zinc for steel bars and casting concrete, and then reinforcing with fibers, where I decreased by approximately 6.0% with no cracks in the shear zone the collapse load was at 61 *kN*, In the following figure 12 shows the cracks pattern.

By examining the corroded un-repaired RC beams, one longitudinal crack appeared at the bottom soffit of the specimen and the other crack appeared on the sides as shown in Figure 12. The average longitudinal crack width before sealing of the corrosion cracks was 0.4 mm. When the repaired specimens were exposed to further corrosion, the sealed cracks did not open, and there was hardly any other longitudinal cracking observed. Figure 5 clearly shows that the FRP repair process reduced the crack opening by about 88% at the end of corrosion process. This implies a significant enhancement in appearance of FRP repaired corroded specimens by reducing crack opening due to further corrosion.

Table 4 shows, the less effectiveness of the concrete repair technique compare to grout technique was used in B3. Figure 12 shows, B4 was showed similar cracking behavior as B1 and better

than B2. Fine flexural cracks were formed at the middle of the beam and under loads as shown in Figure 12, and the maximum load was the 55 kN at failure.

This explains effectiveness of the concrete repair method strengthening with CFRP. As for the cracks in beam No. 5 .It showed the first crack observed at 5 ton. Fine flexural cracks were formed at the middle of the beam as shown in figure 12, the shear zone was almost free from cracks, and the maximum load is the 6.1 ton and starting failure , and completely different from the behavior of cracks in Beam No. 1, which showed cracks in shear area and in the middle of the beam, and this is the opposite of what we saw in Beam No.5 which did not show cracks in the shear area , it is also different from Beam No. 2, which showed cracks in the shear area with deterioration in the concrete cover .
